3.0 Environmental Monitoring

3.1 VADEQ Environmental Monitoring Data

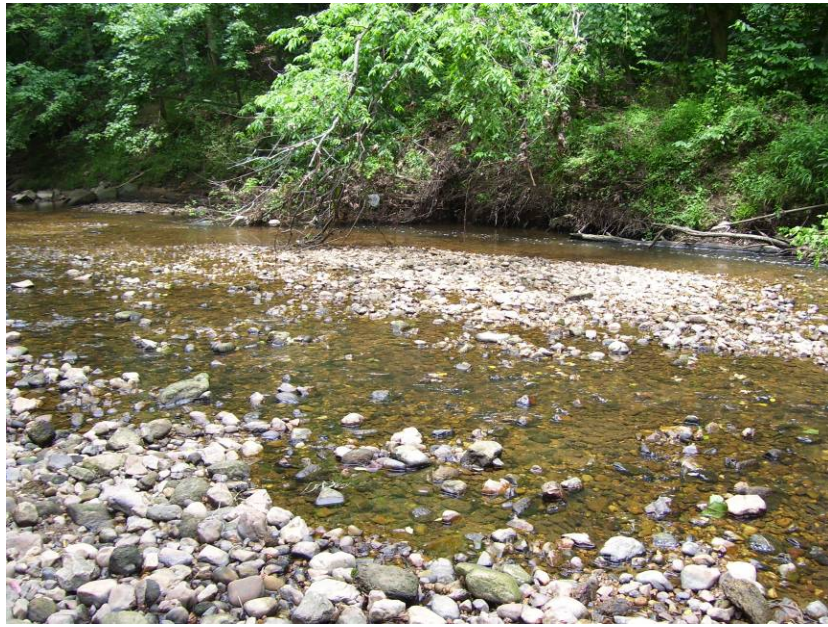
The mean sediment particle size in Accotink Creek at stations 1AAC006.10 and 1AAC009.10 is within the cobble (64 to 250 mm) range (**Figure 3-10**). The sediment mean particle size in the upper Accotink stations is greater than the average mountain ecoregion stream (Hill Memo, 2007). These particle sizes are in the upper quartile statewide. At station 1AAC004.84 the mean particle size is closer to course gravel.

Figure 3-10: Example of Mean Particle Size Commonly Found Along the Impaired Reach of Accotink Creek. June 2008 RBS Study, Station 1AAC0006.10

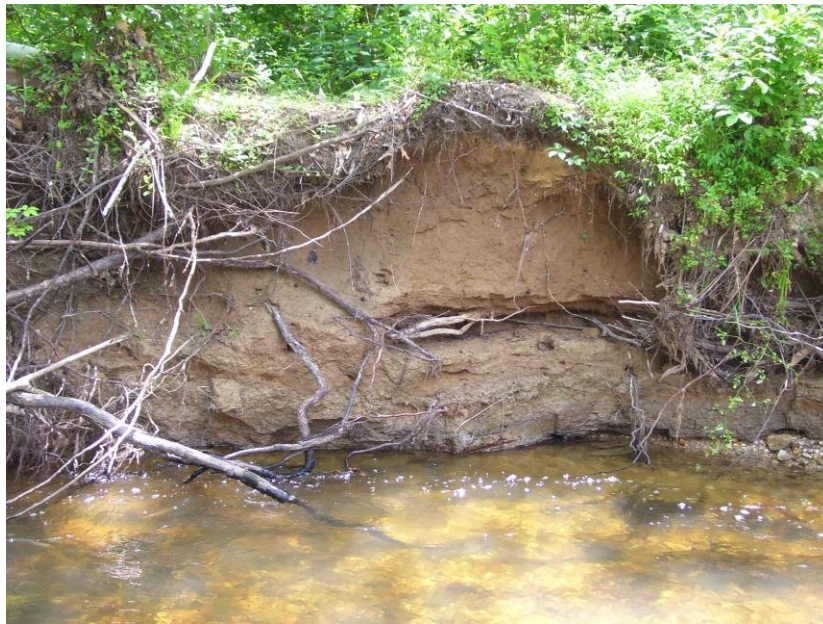
Analysis of the relative bed stability studies indicate that altered hydrology has led to a scoured, eroded stream, which leaves behind a higher than expected median particle size (**Figure 3-11**).

Figure 3-11: Stream Bank Erosion Typical of Accotink Creek. June 2008 RBS Study, Station 1AAC004.84

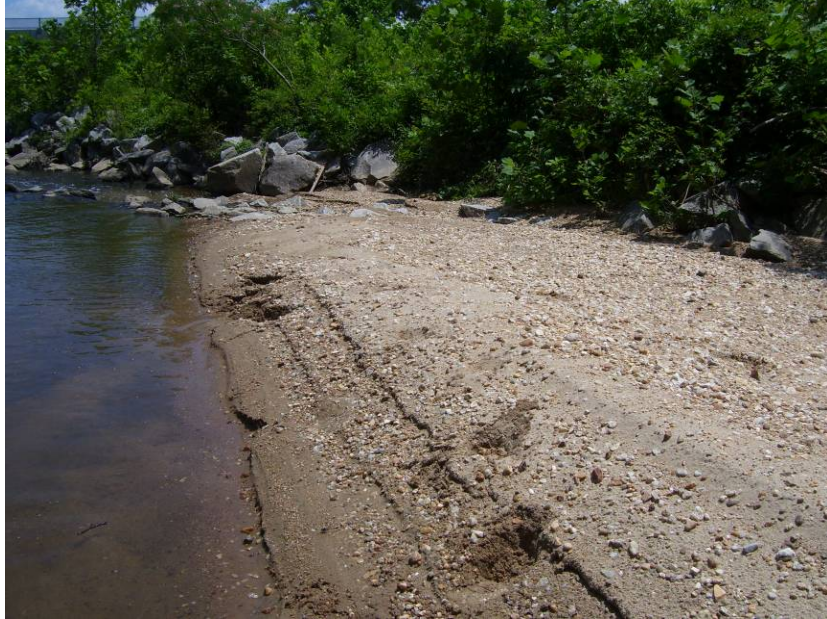
habitat database. Sediment that erodes from the banks of Accotink Creek along the impaired segment is deposited further downstream in the Accotink Watershed, closer to the tidal boundary (**Figures 3-12 and 3-13**).

Figure 3-12: Coarse Gravel and Sediment Deposits at Station 1AACO004.84 (Telegraph Road)

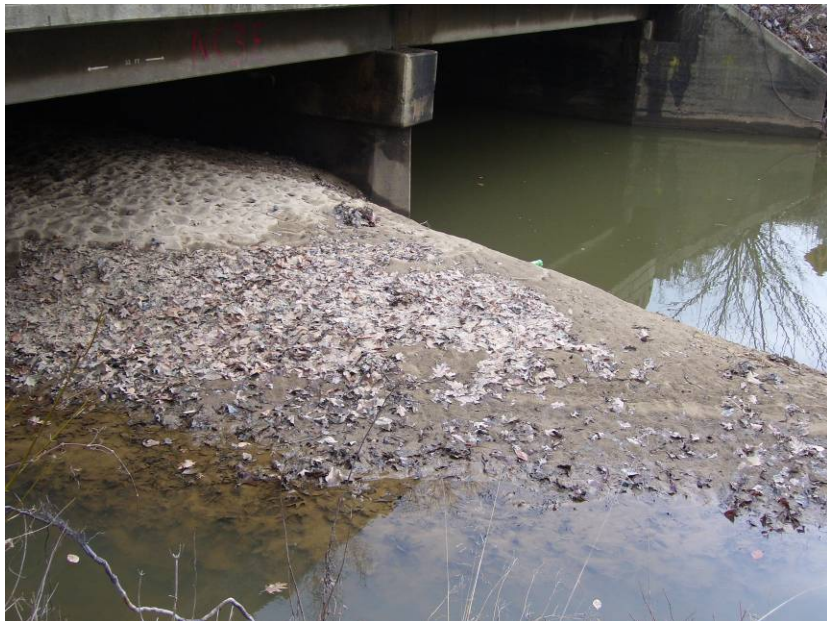
Figure 3-13: Fine Sand Deposit Located Under the Route 1 Bridge over Accotink Creek, near the Tidal/Non-tidal boundary
